**CONDITION SURVEY**

Date: August 31, 2023

Re: Structural Condition Survey  
Monroe Middle and High School  
Stadium Bleachers and Interior Pull-Out Bleachers

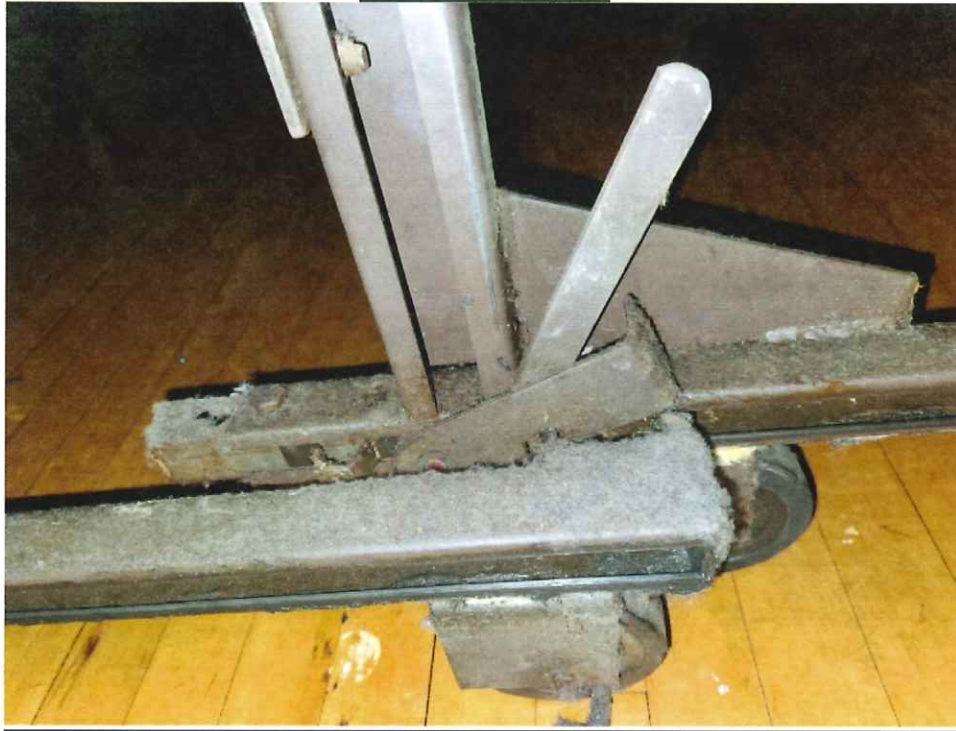
Photograph 1 – Undamaged locking mechanism with lever – Middle School

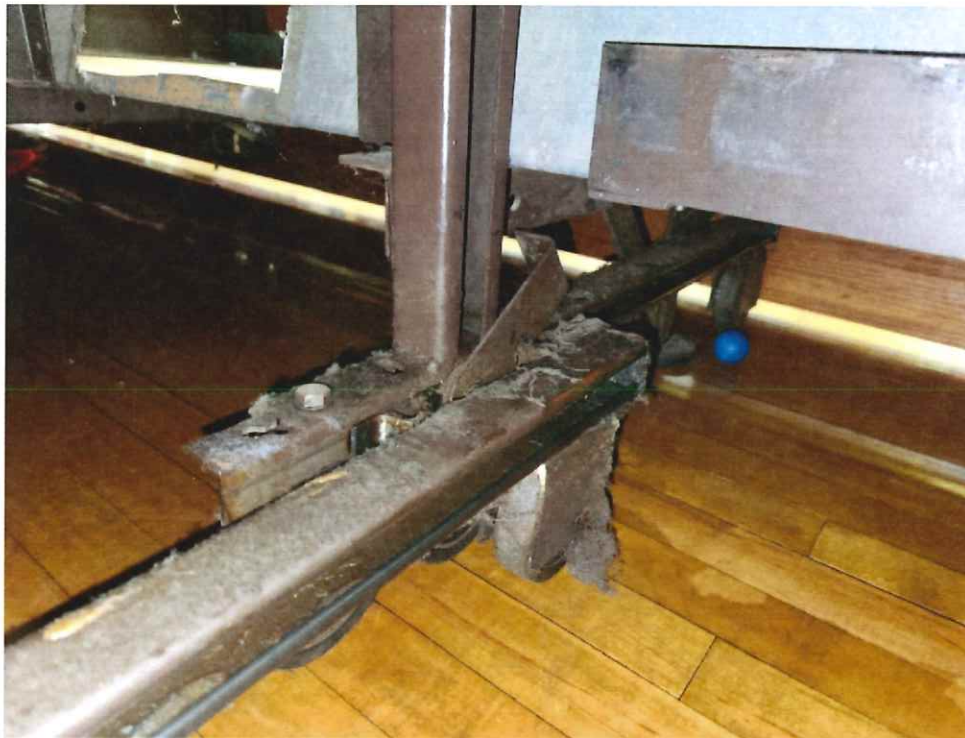
The structure is in good condition. School personnel mentioned that they are having difficulty storing the bleachers on one side of the gymnasium. This is due to a missing steel lever that unlocks the sliding mechanism as the bleachers are pushed into the storage position. See attached photographs 1 and 2. Photograph 1 shows the undamaged locking mechanism lever and photograph 2 shows the bracket with the missing steel lever piece that is activated as the bleachers are pushed into the storage position. This likely occurred due to fatigue over time. This condition is not a structural concern but makes the bleacher storage more difficult. A new piece of steel will need to be bolted to the bracket shown in photograph 2 to match the undamaged brackets or the bracket may be replaced by a bleacher manufacturer/installer if the

Photograph 2 – Damaged locking mechanism lever – Middle School

parts are still available. This locking mechanism can be activated manually until the bracket can be repaired or replaced.

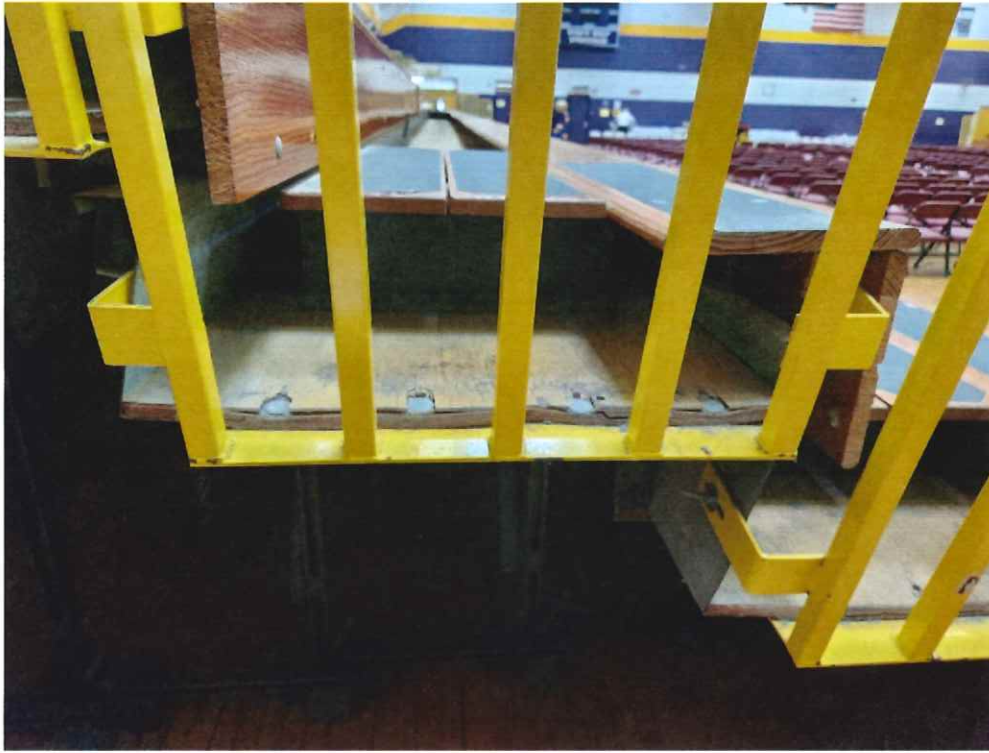
Photograph 3 – Deteriorating railing support – Middle School

There are deteriorating railing base supports on one end of a bleacher (Photograph 3 and 4). It is recommended that the bolts supporting the railing bracket be removed, a new piece of 3/4" plywood x 24" long be glued with construction adhesive and bolted to the top of the existing floor plywood with 1/4" diameter carriage bolts and washers underneath +- 2" from the end of the plywood opposite of the railing. The original railing bracket bolts are to then be reinstalled through the new and existing plywood. Verify no bolt projections below the flooring will interfere with the operation of the bleacher.

The middle school gymnasium bleachers require remedial work as described above. The bleachers may continue to be used but the plywood railing support indicated above is to be fixed as soon as possible. The mechanical moving parts of these bleachers were not inspected by our office for adequacy nor was it in our scope of work. This work should be completed by a manufacturer or installer contractor for this type of moveable bleacher.

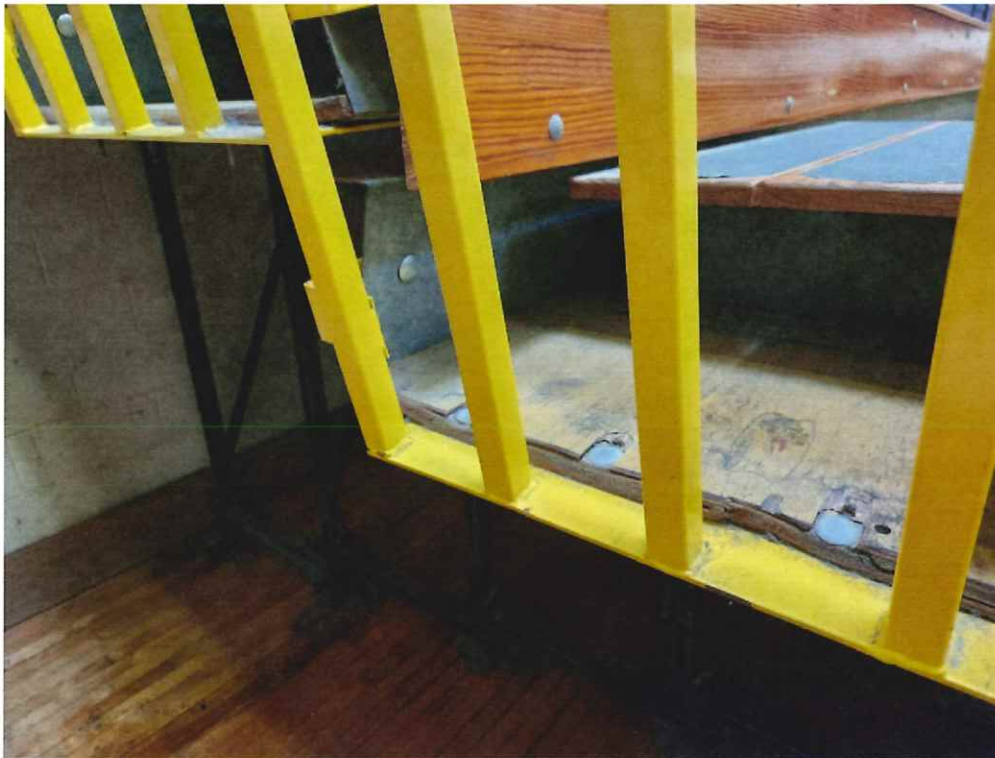
Photograph 4 – Deteriorating railing support – Middle School
